HouseWise
Home Inspection Report

[REDACTED] Queensbury, NY
Inspection prepared for [REDACTED]
Date of Inspection: 10/3/2020 Time: Noon

Inspector: Russell Melville
16000044199
326 1/2 W. Maple St., Corinth, NY 12822
Phone: 518-654-6293
Email: russjmel@gmail.com

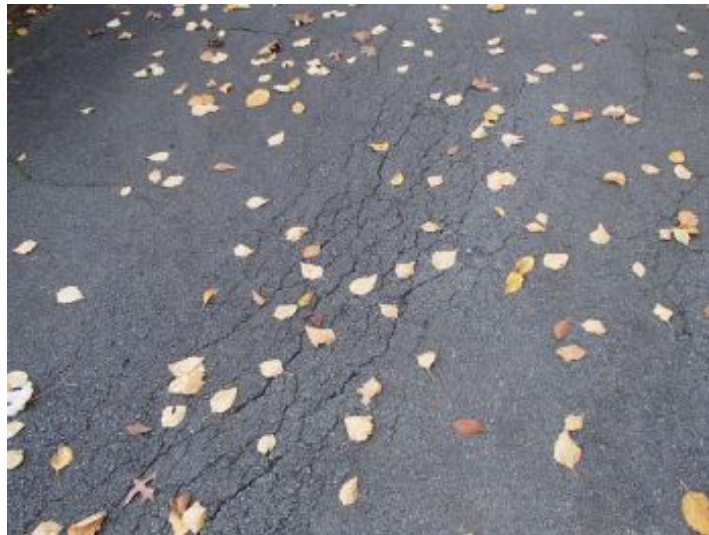
- Asphalt driveway is in poor condition, cracked, deteriorated, heaved due to tree roots and delayed maintenance.
- Recommend review by a qualified professional for repair or replacement as necessary.

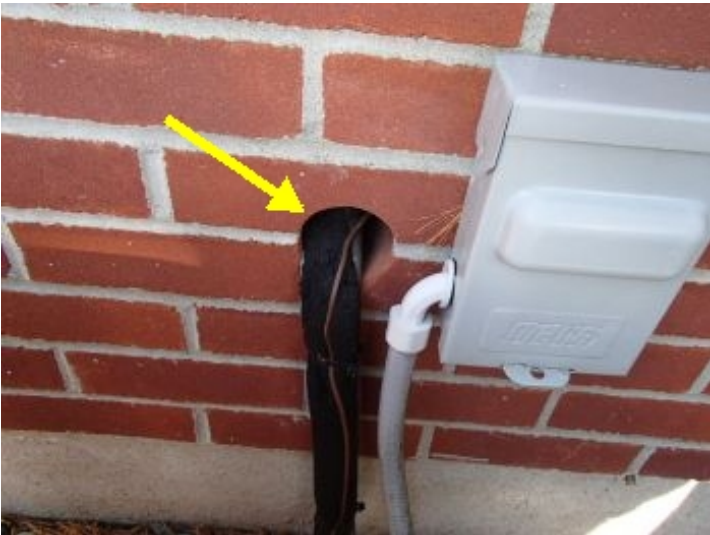
- Brick siding is damaged due to guttering issues, as pictured. Recommend a qualified mason evaluate and repair, or replace brick as necessary.
- Rodent access noted. Recommend holes be plugged.

2 ac line holes allow vermin entrance

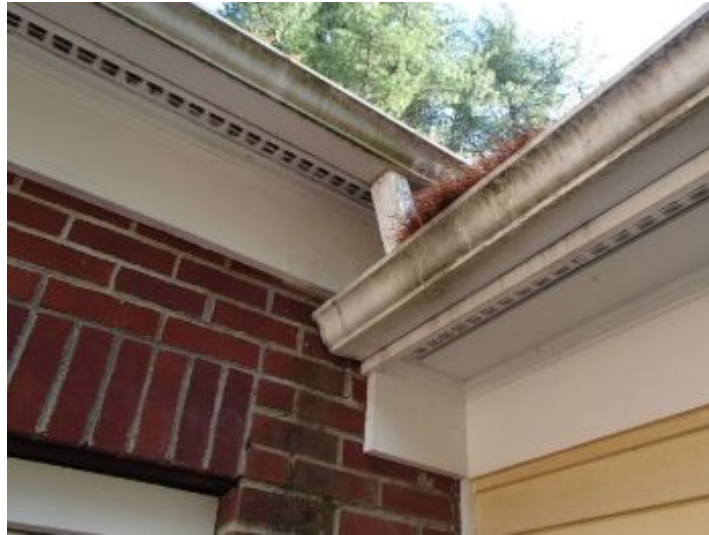
gutter water damaging brick

gutter backing up against siding

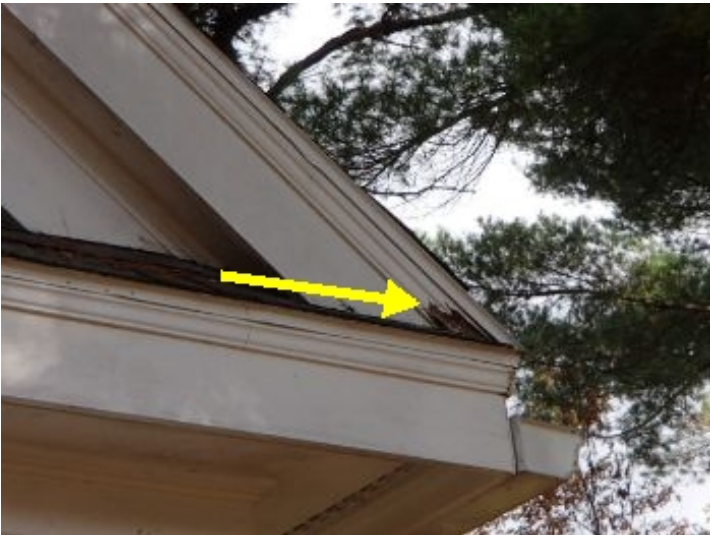
- Soffit areas are darkened due to lack of ventilation, trees, shade, as pictured. It appears to be mold.
- Damaged/missing/lose as pictured.

wood rot

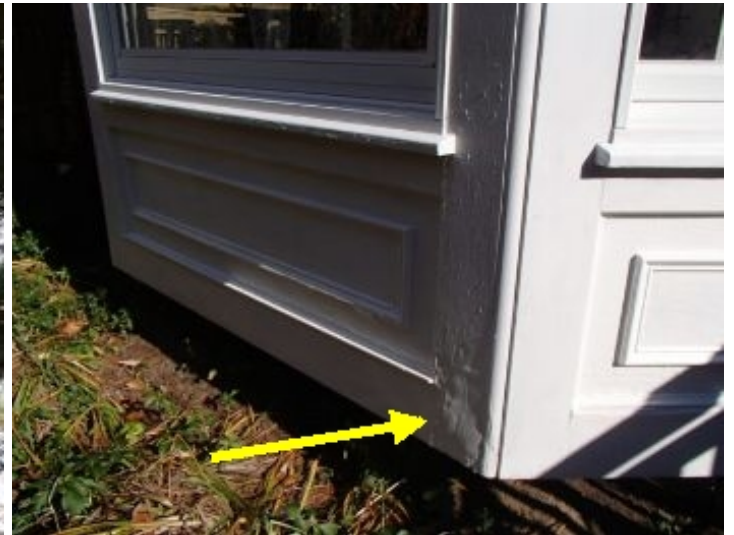
wood is patched, soft

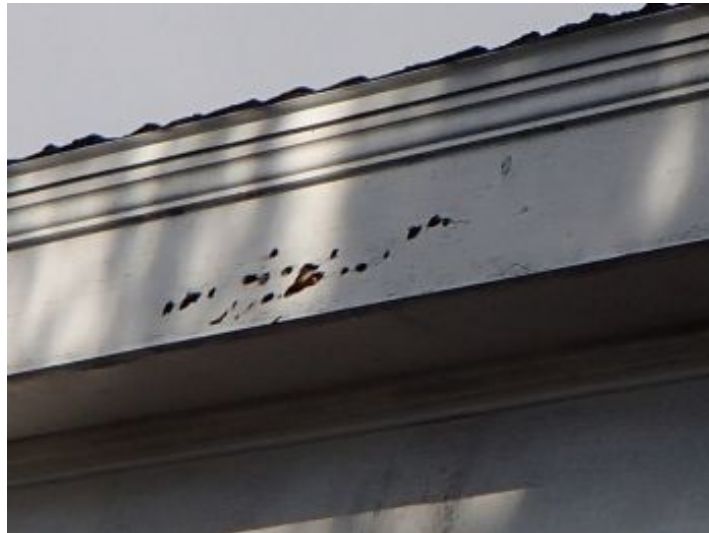
wood pecker or carpenter bees?

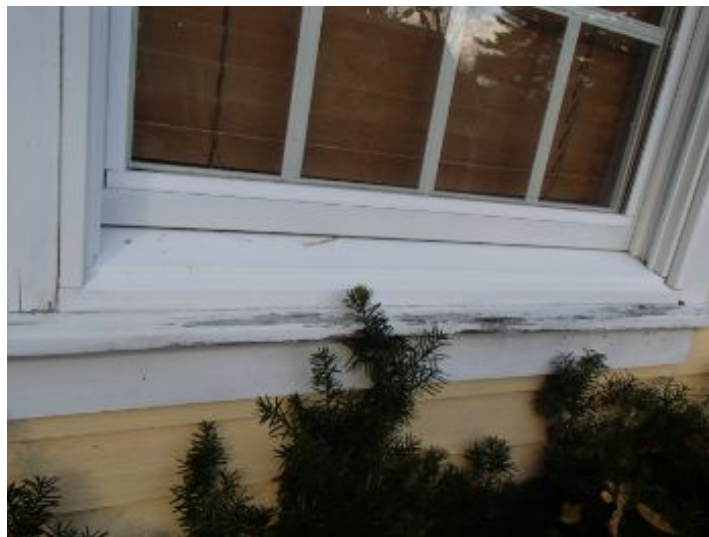
paint

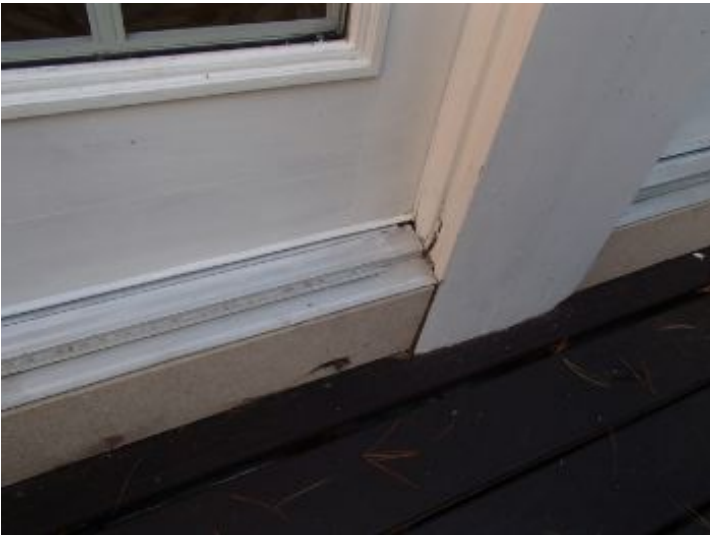
- Wood deterioration noted, due to guttering issues, roof water splashing off the deck onto the doors. Soft water damaged wood has been painted over. Suggest repairs/replacement as needed.

water damage to doors

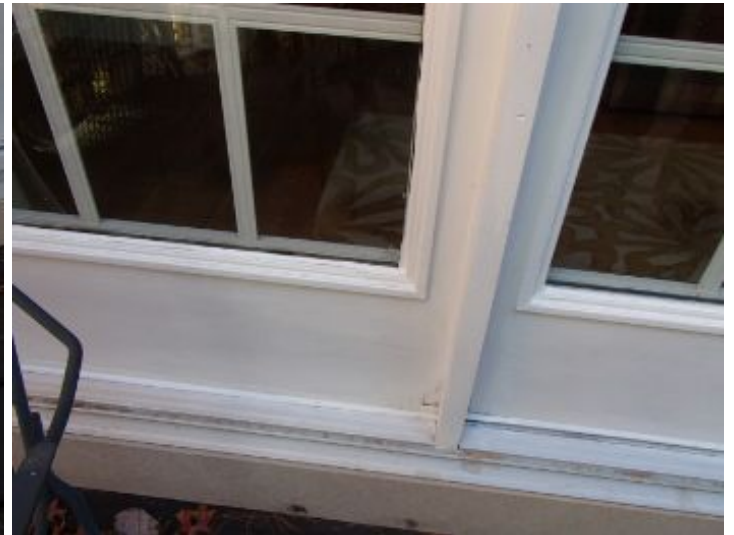
painted over water damage

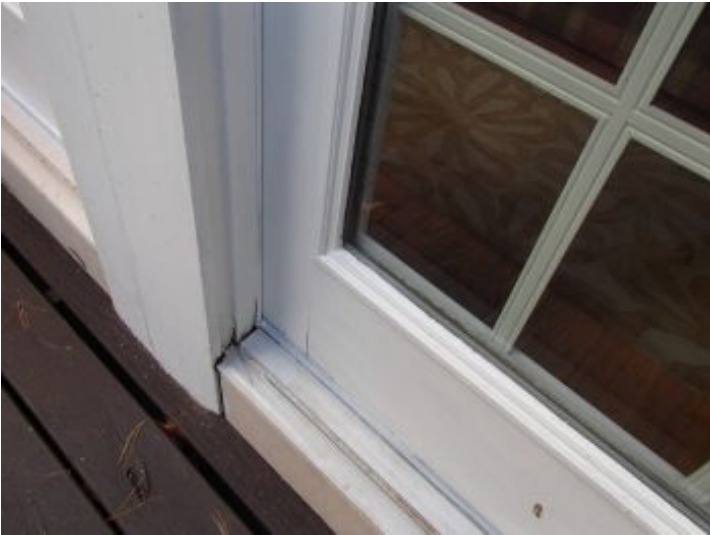
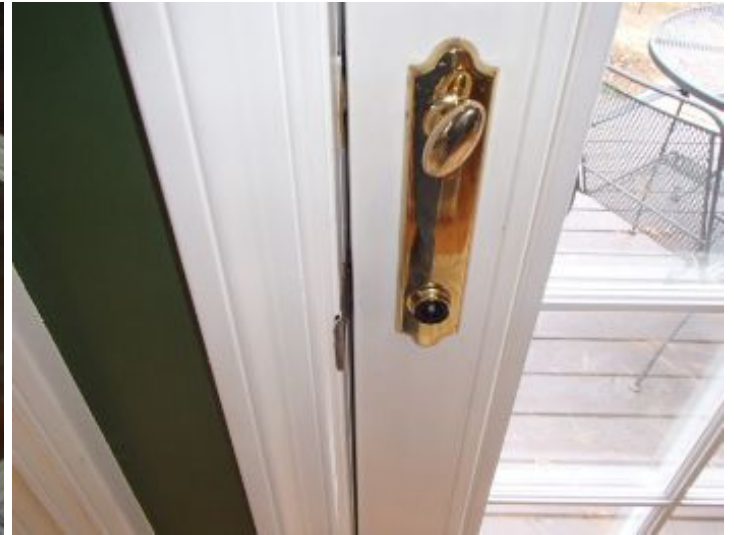
handle missing

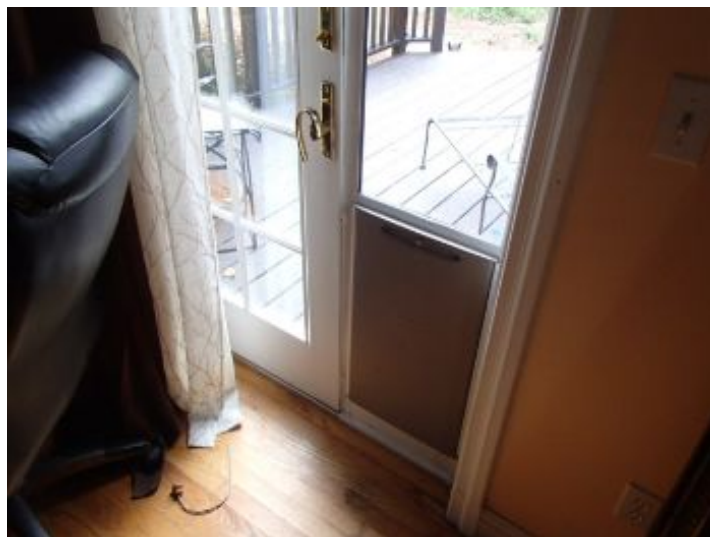
pet door not tested

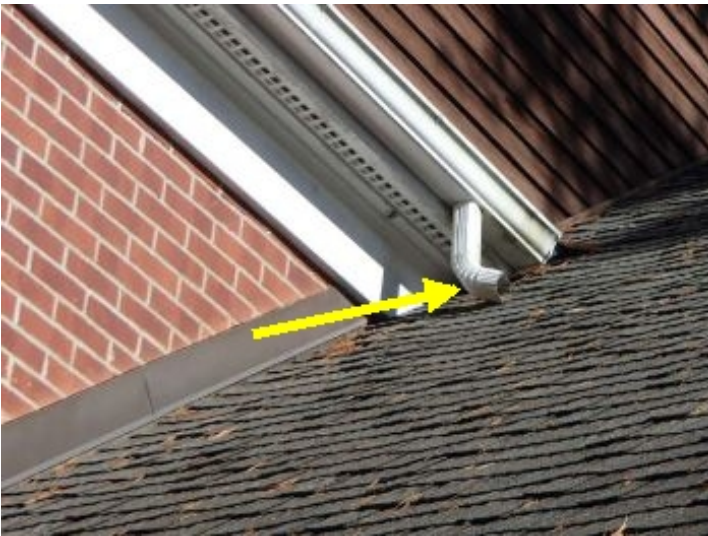
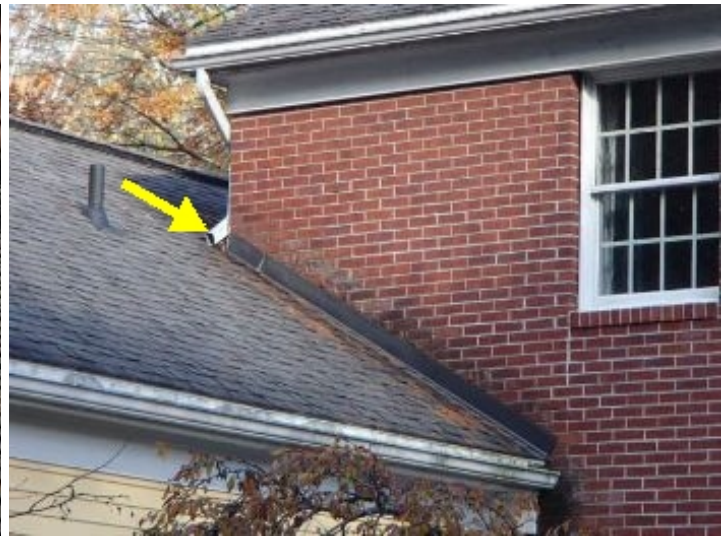
- Clogged gutters noted. Suggest gutters be cleaned out as a part of a normal maintenance routine to ensure proper drainage.
- Gutter are getting overwhelmed with water during heavy rain, as there is excessive length in proportion to the downspouts.
- Gutter missing as pictured, at one story addition. See basement wall section.
- Downspout(s) from upper roof discharges water onto roofing surface of lower roof. This will prematurely wear out shingles in this area. Recommend extending downspout to lower gutter to prolong single life.
- Recommend review for repair or replacement as necessary.

termination on the roof, overwhelmed gutters

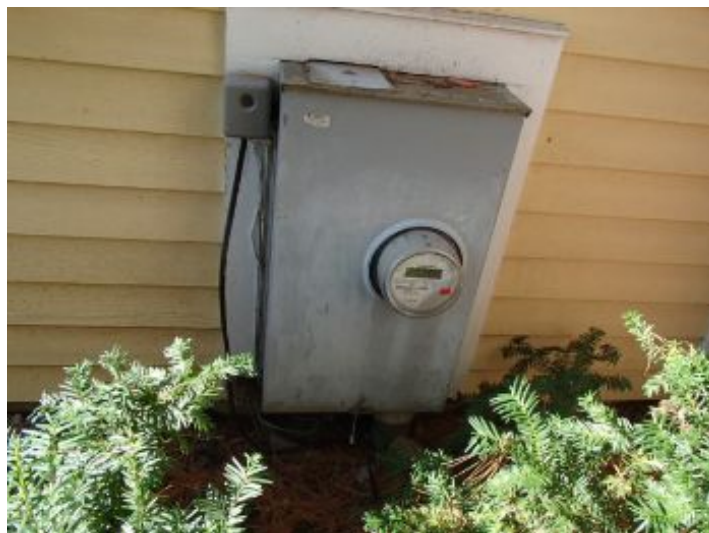
- Meter is too close to the ground, as it should be a minimum of 4 feet above grade. Recommend raising the meter by a qualified person.

meter at grad level

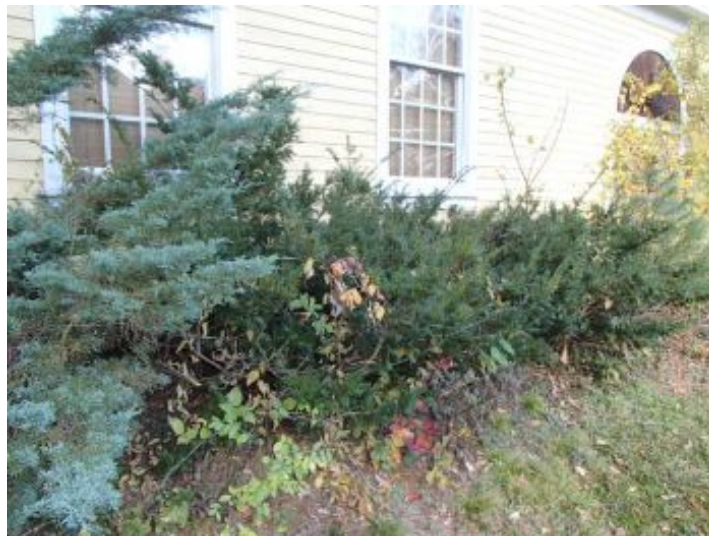
- Trees, shrubs growing too close to the foundation. This will cause damage due to roots, moisture issues.
- See basement section for more information.

area where foundation is bowed, no gutters, vegetation

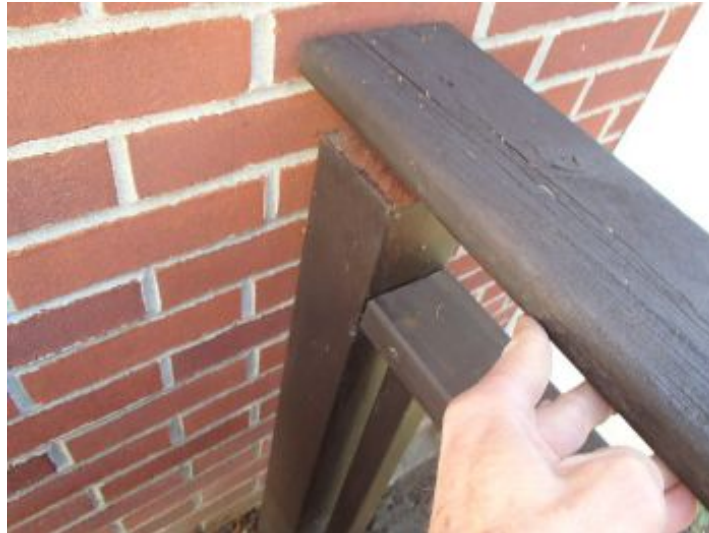
Observations:
 • Damaged as pictured.

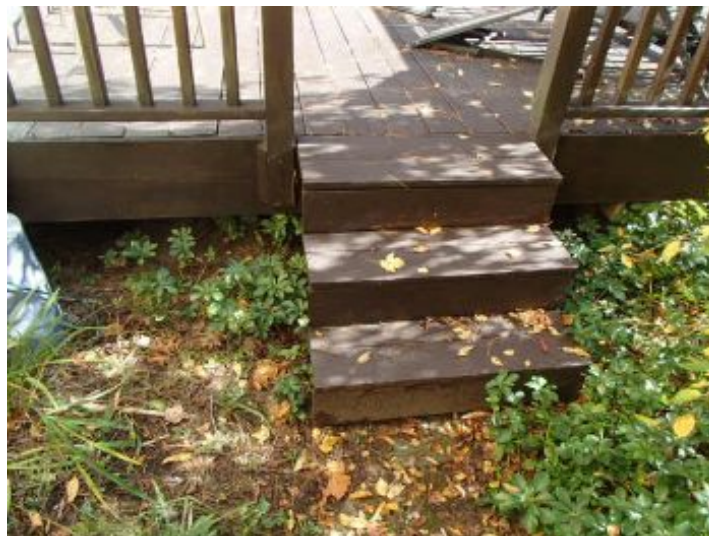
• Hand railing is missing as pictured. Recommend railing be added to stairs.

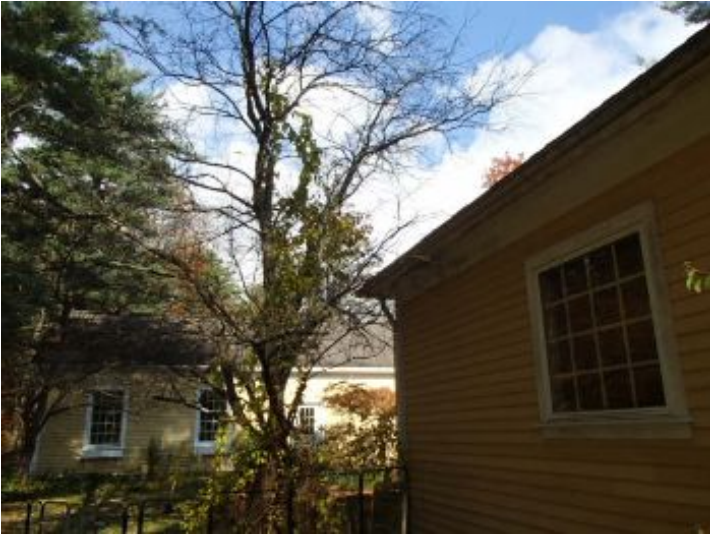
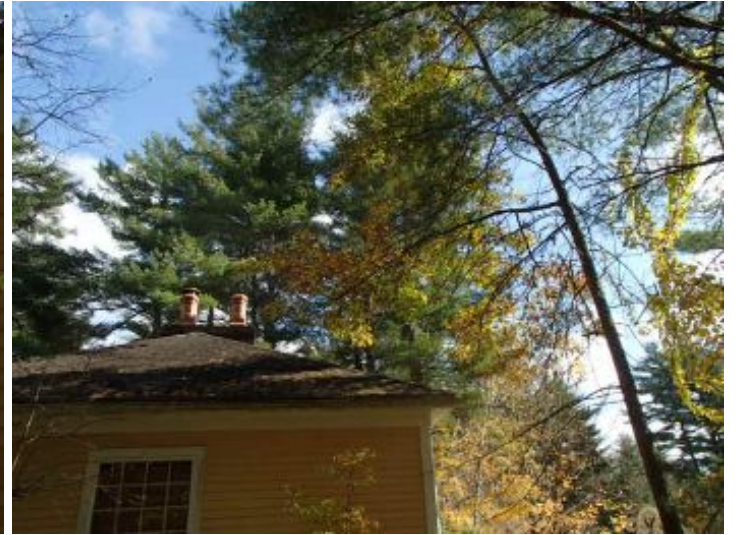
• Trees/vegetation against siding and foundation will encourage high moisture environment, damaging building components.

trees too close to home

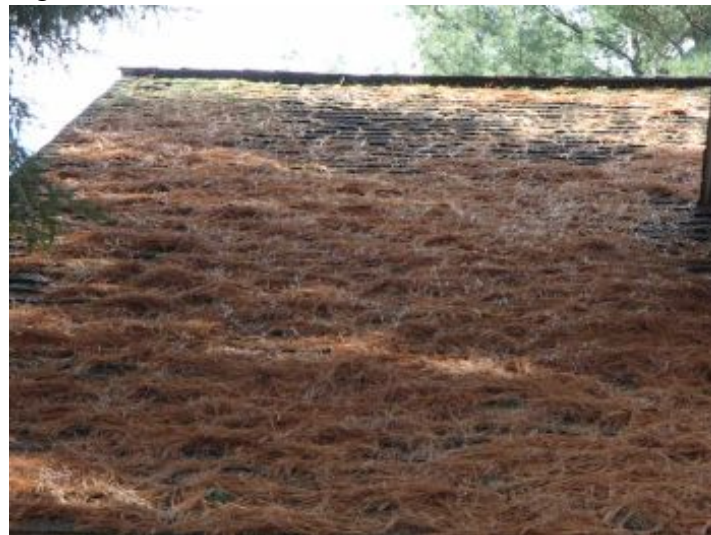
• Moss noted as pictured. This will eventually shorten the life of the shingles. Recommend a qualified person treat the roof surface to remove moss according to acceptable practice for asphalt roof shingles. Condition of shingles under moss could not be determined.

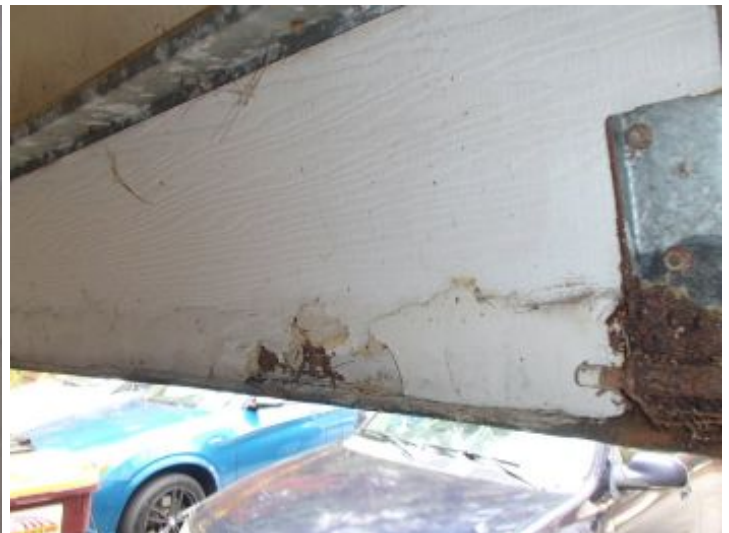
- Damage noted to metal door as pictured, corrosion, it has been painted over.

corrosion, rot on door

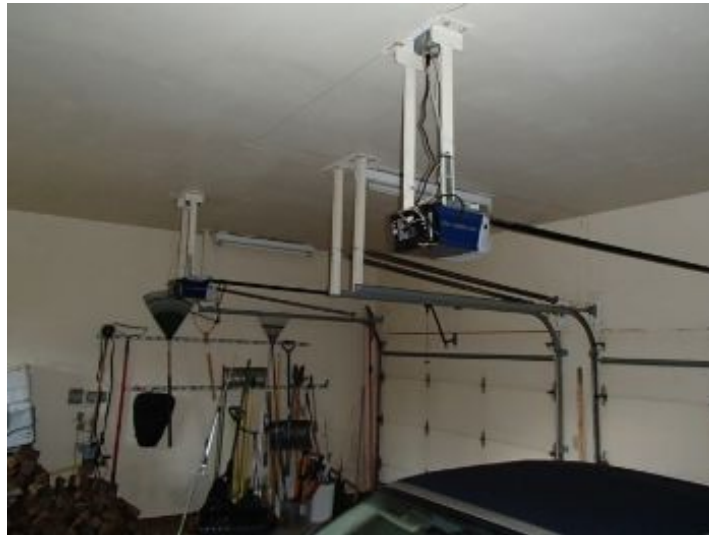
- Door opener is inoperable on 2 of 3 doors.

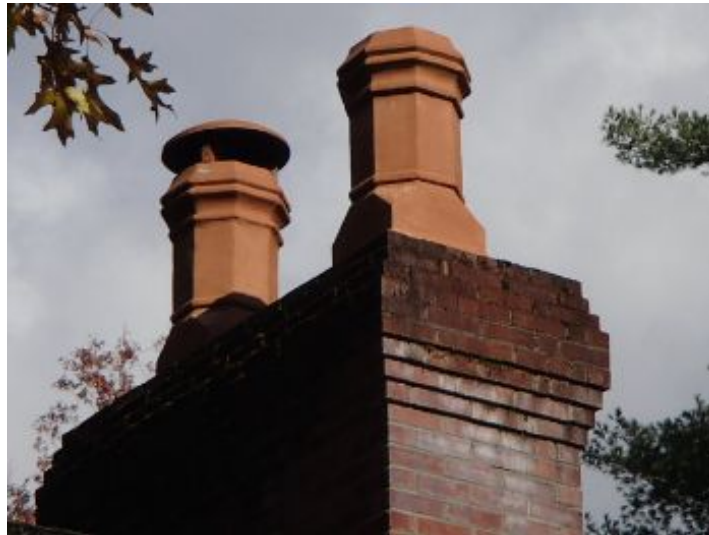
- Recommend that all masonry chimneys undergo a level 2 inspection by a qualified professional.
- Recommend regular maintenance of masonry chimney crowns, and waterproofing.

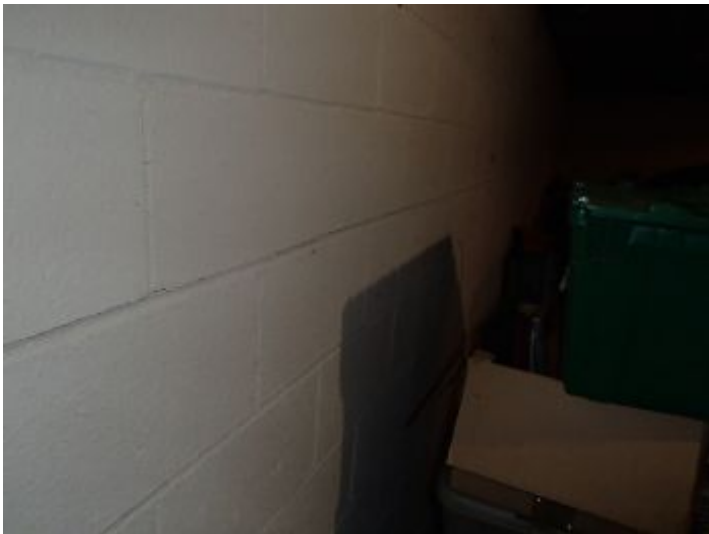
- Efflorescence observed; this is a mineral deposit left behind from exterior water infiltration. Recommend that water be chanelled away from the foundation by the use of guttering, and lot/grade/drainage changes.
- Horizontal crack noted at single story addition. This is due to excessive moisture in the ground that expands during freeze cycles. Damage is minor, but will worsen over time unless guttering is installed, and shrub removal.

horizontal crack

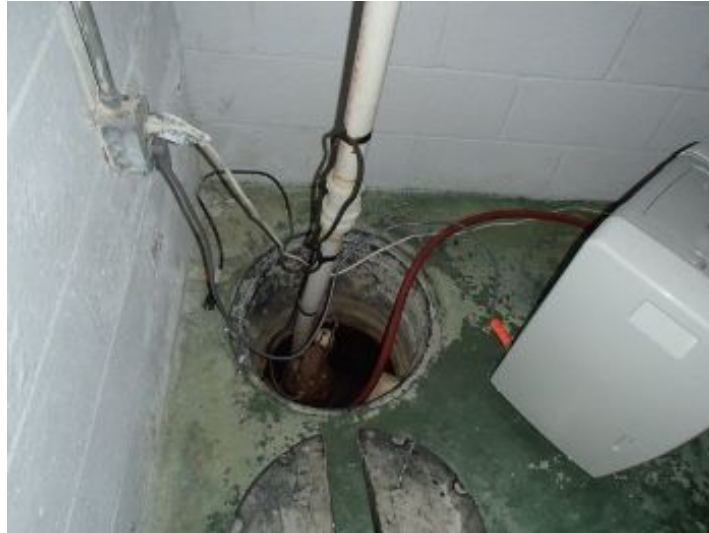
- Sump Pump was not activated at the time of inspection, as there was no water in the pit.

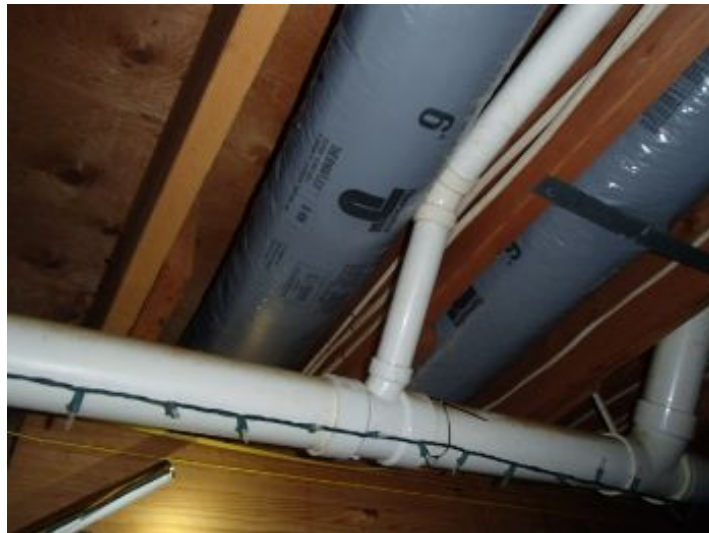
- Sump water is discharging into the septic system. This is not desirable, as it puts added stress on the septic system. Recommend removing sump plumbing from the septic system.

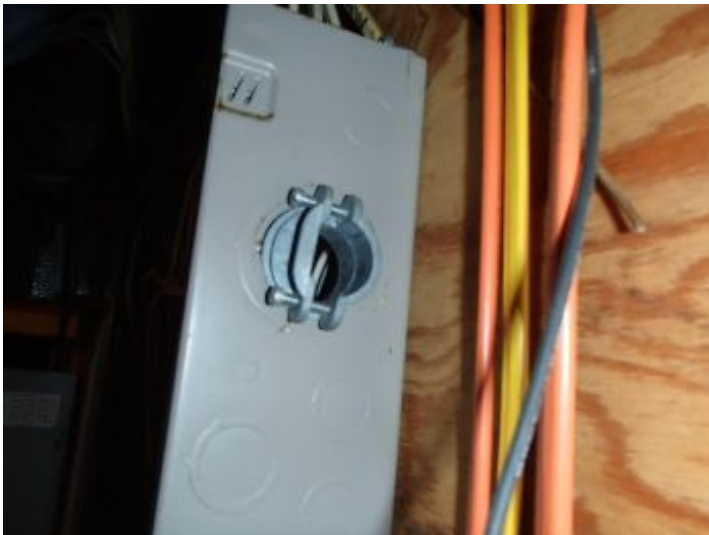
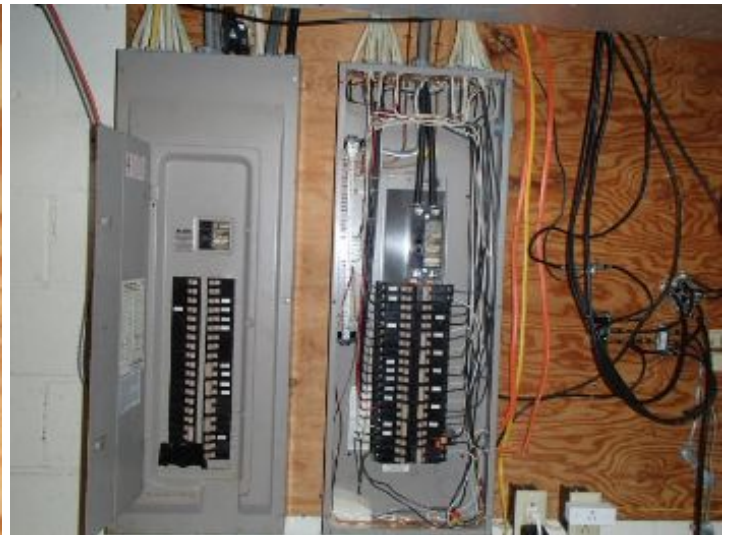
- Knockout missing as pictured from both panels. Recommend repair.
- Over fused wiring noted. Wire is undersize for the amperage of the breaker. There are several 30 amp breakers using 12 gauge wiring. This is a safety hazard.
- Double tapping noted. This is not allowed.
- Recommend review by a qualified professional electrician for repair or replacement as necessary.

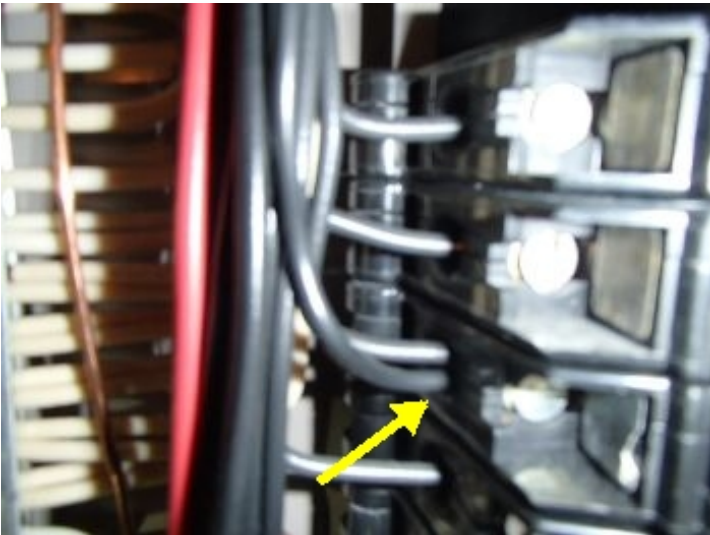
double tapping

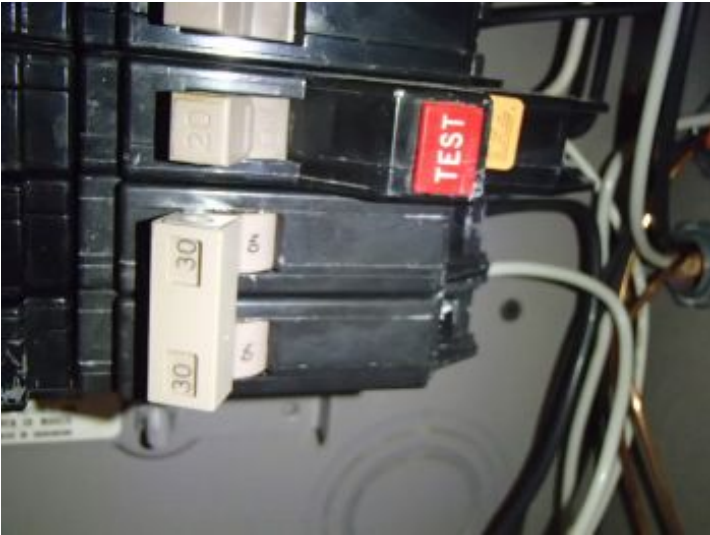
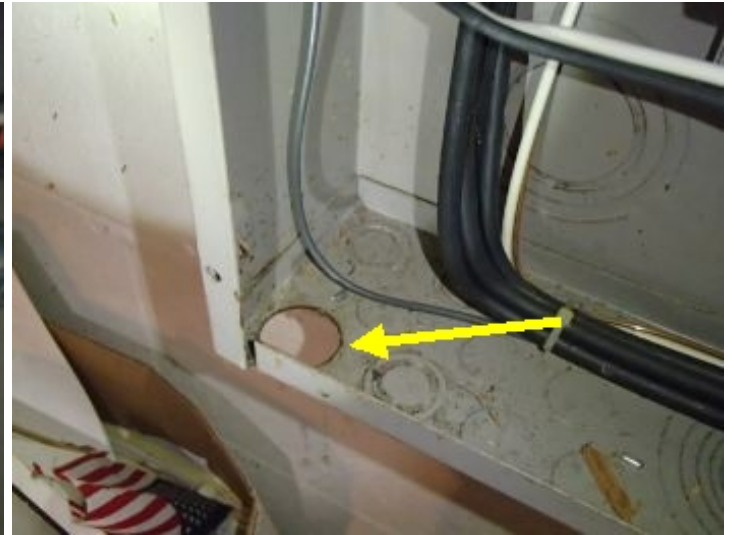
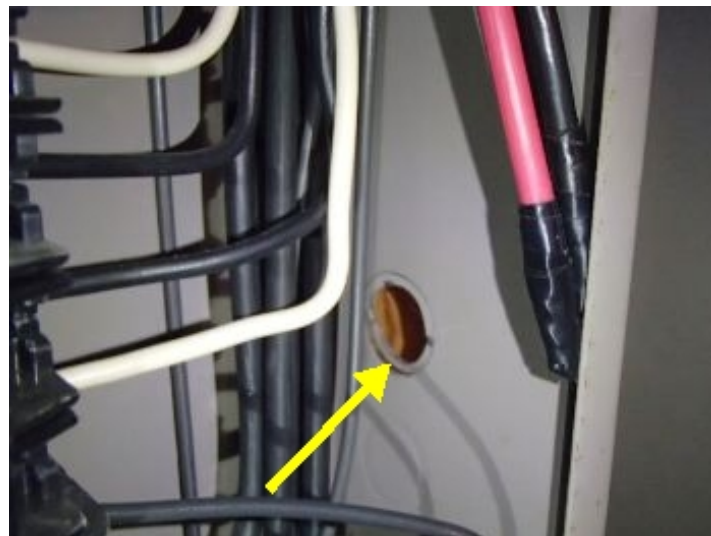
30 amp with 12 gauge

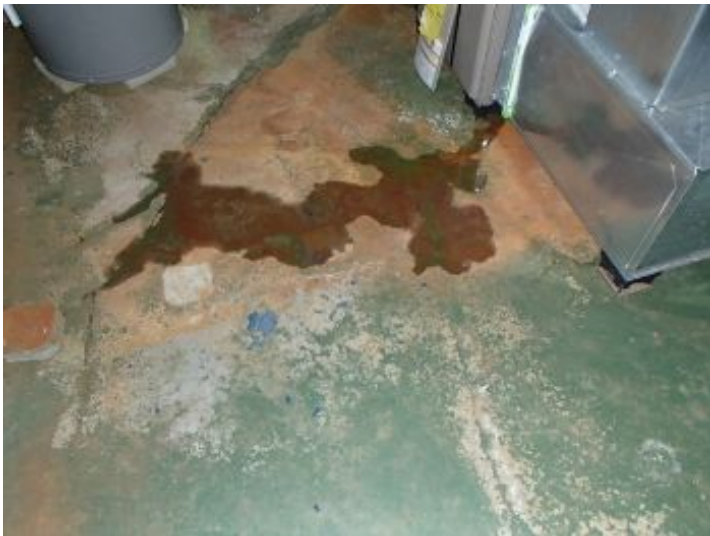
- Water, Corrosion noted inside one of the furnaces. Cause of corrosion was likely due to condensate leaking.
- Recommend review by a licensed heating contractor for repair or replacement, as necessary.

condensate leaking

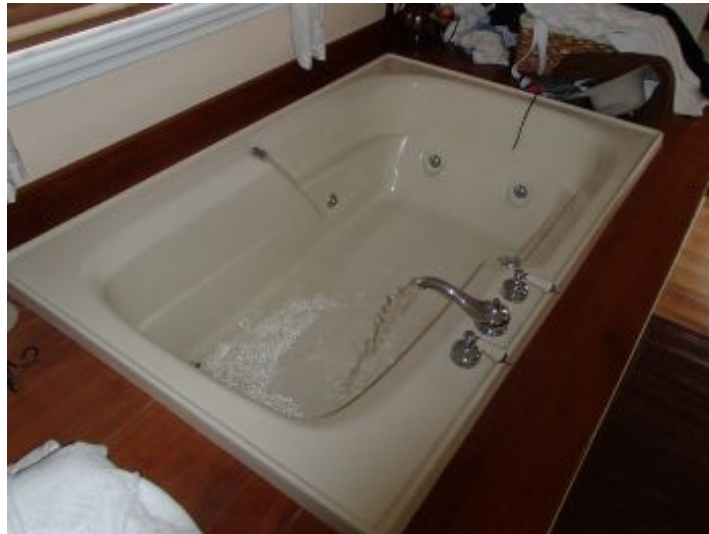
not tested

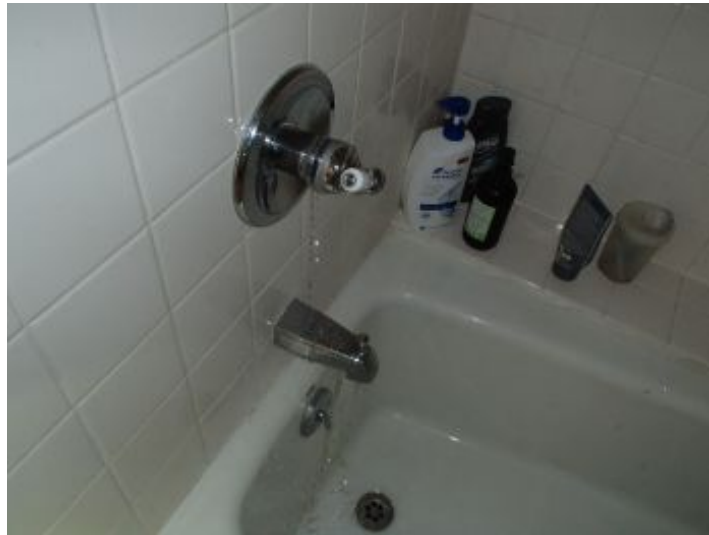
- Shower diverter does not fully engage.
- Shower diverter is leaking

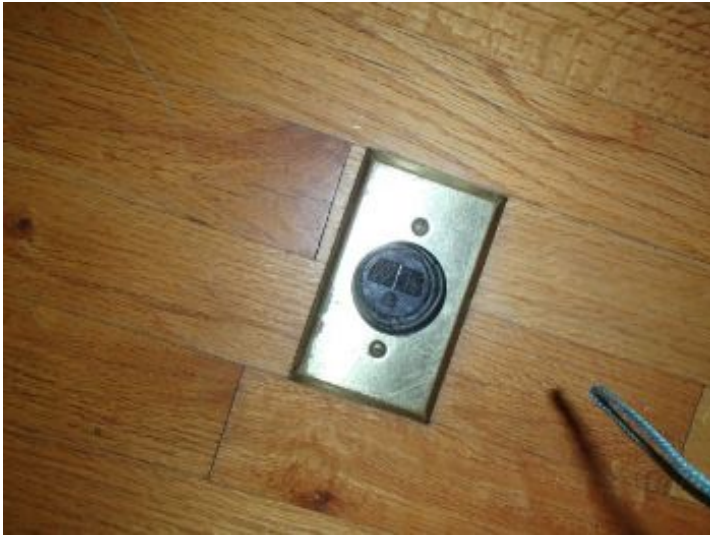
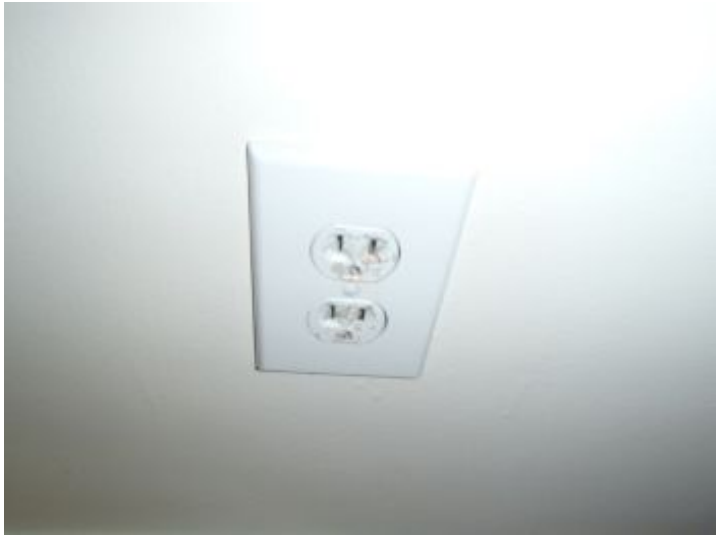
- Floor outlet is dangerous and should be removed.
- Outlets painted over. These outlets should be replaced by a qualified person.

Painted outlets

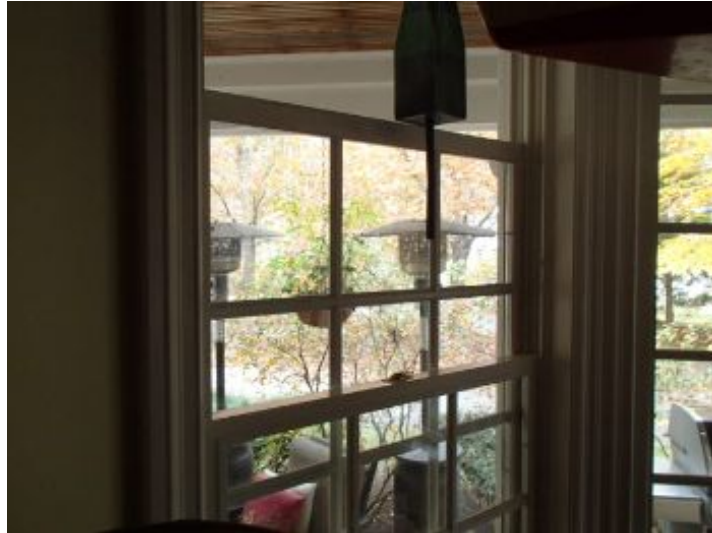
- One Window springs did not function.
- Recommend a qualified person evaluate and repair or replace as necessary.

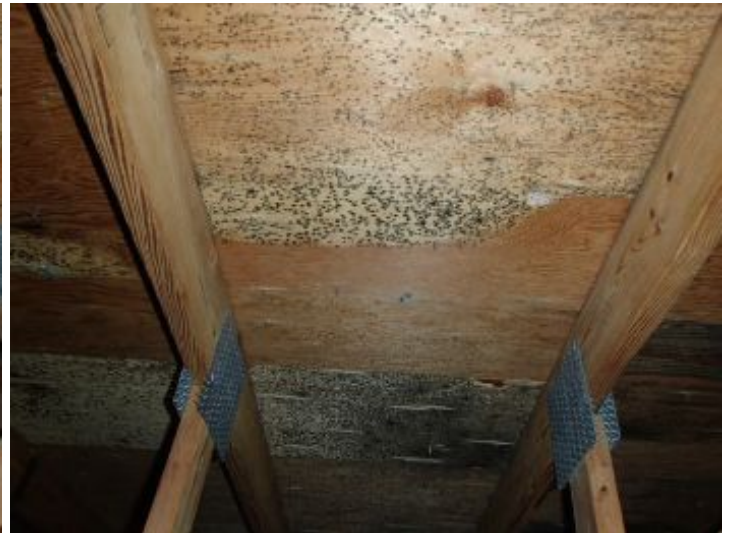
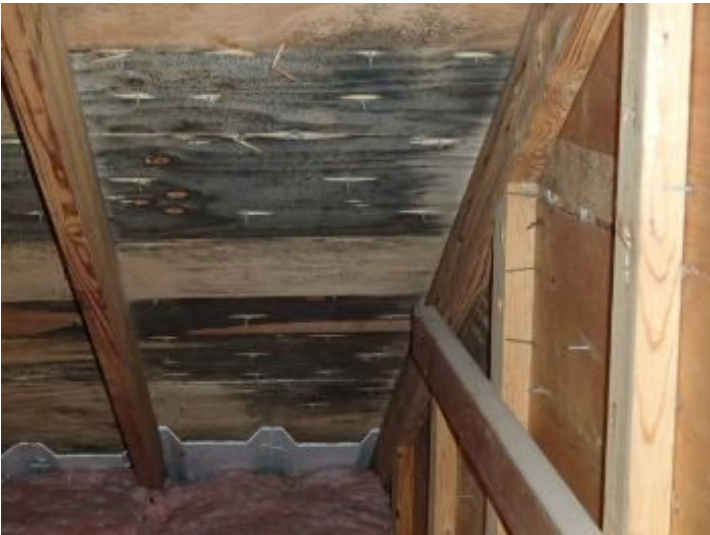
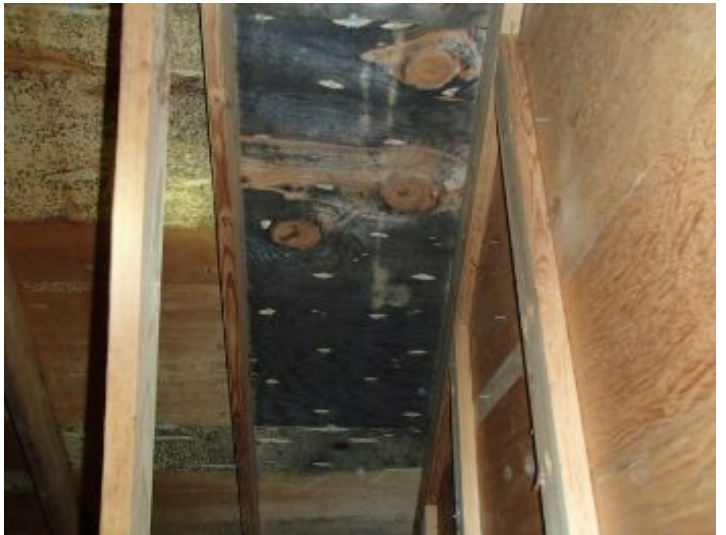
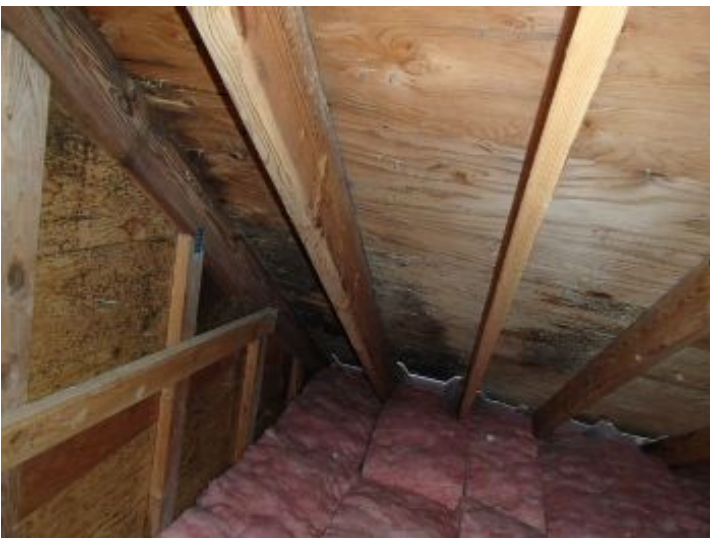
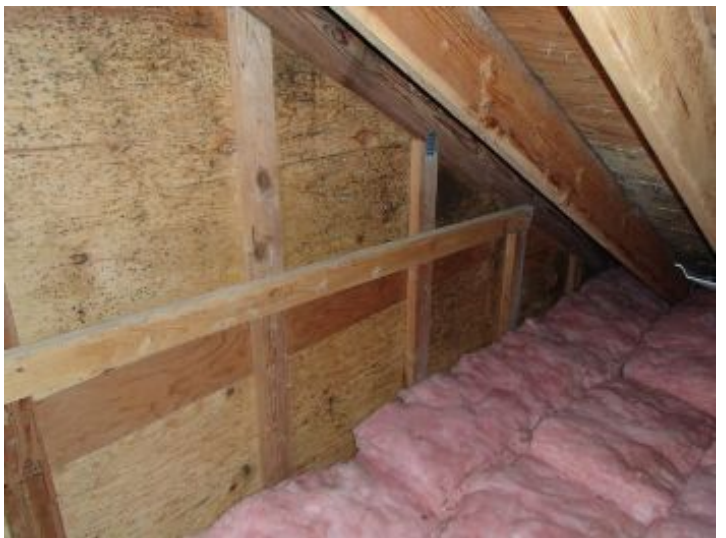
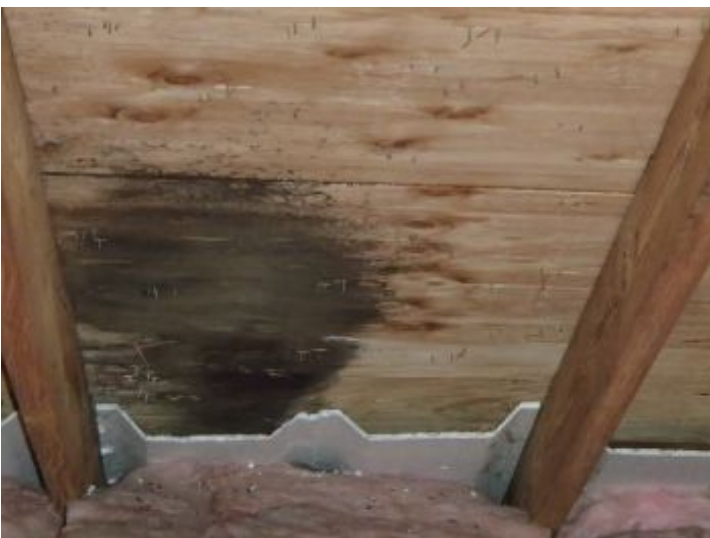
• Mold like growth as pictured on roof sheathing. Area of mold exceeds 10 sq. ft. Mold can be a health hazard. Recommend that a Mold Assessor evaluate and advise client on remediation.

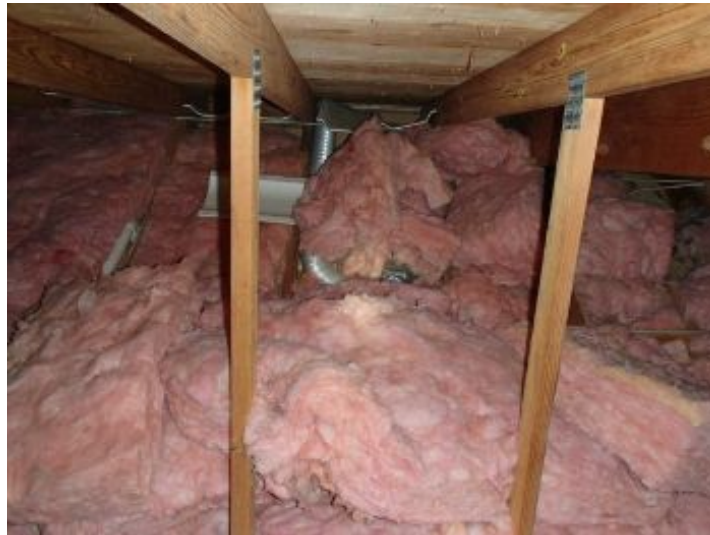
- Bathroom duct terminates in the soffit area. This moisture can be drawn back into the attic through the soffit vents. Recommend terminating through the roof or gable end wall.

garage attic bathroom venting in soffit

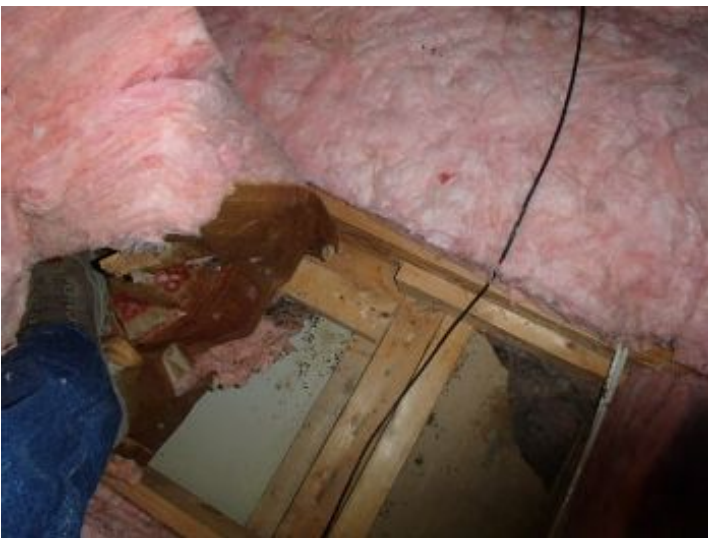
- Rodent droppings observed. Recommend an qualified person evaluate, exterminate and make alterations to prevent rodent access into the home.

mouse droppings

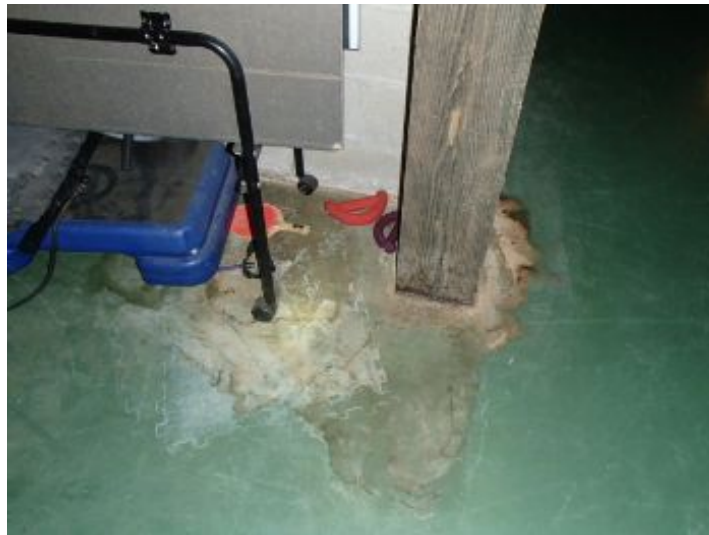
- It appears there are some condensate leakage issues.
- Recommend all solid fuel burning appliances and venting be inspected by a qualified chimney sweep.

leaking chimney in basement from cleanout
