HouseWise
Home Inspection Report

[REDACTED] Queensbury, NY
Inspection prepared for [REDACTED]
Date of Inspection: 10/3/2020 Time: Noon

Inspector: Russell Melville
16000044199
326 1/2 W. Maple St., Corinth, NY 12822
Phone: 518-654-6293
Email: russjmel@gmail.com

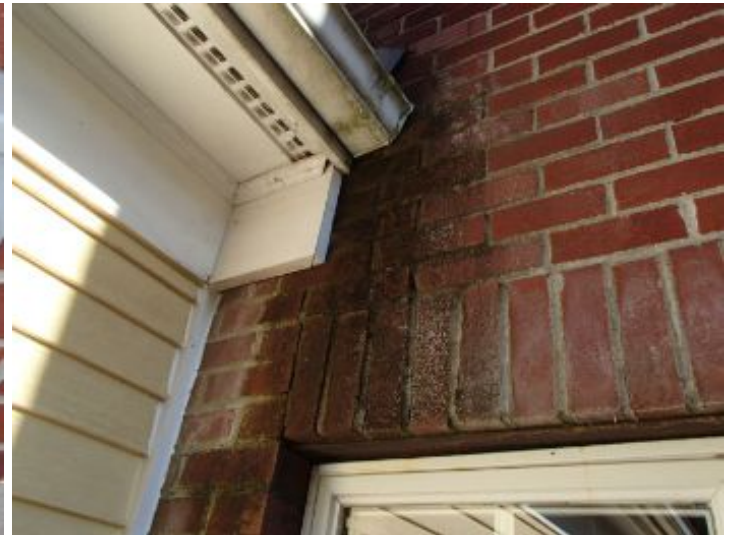
- Brick siding is damaged due to guttering issues, as pictured. Recommend a qualified mason evaluate and repair, or replace brick as necessary.
- Rodent access noted. Recommend holes be plugged.

gutter water damaging brick
