HouseWise
Home Inspection Report

[REDACTED] Queensbury, NY
Inspection prepared for [REDACTED]
Date of Inspection: 10/3/2020 Time: Noon

Inspector: Russell Melville
16000044199
326 1/2 W. Maple St., Corinth, NY 12822
Phone: 518-654-6293
Email: russjmel@gmail.com

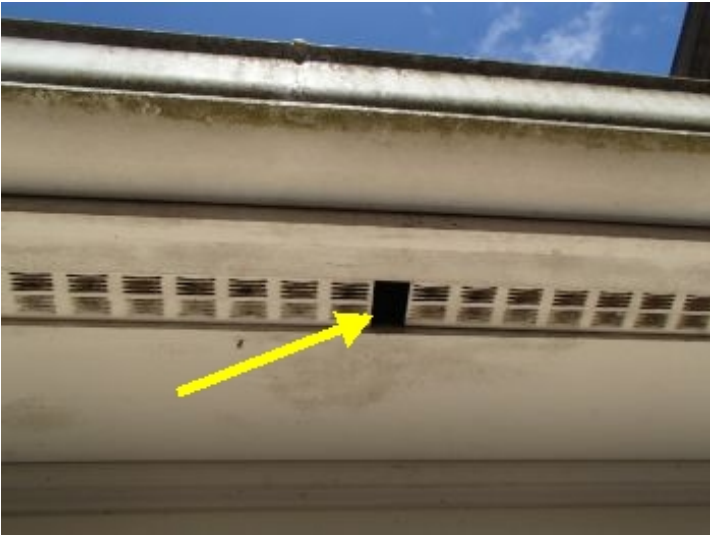
opening for birds and vermin

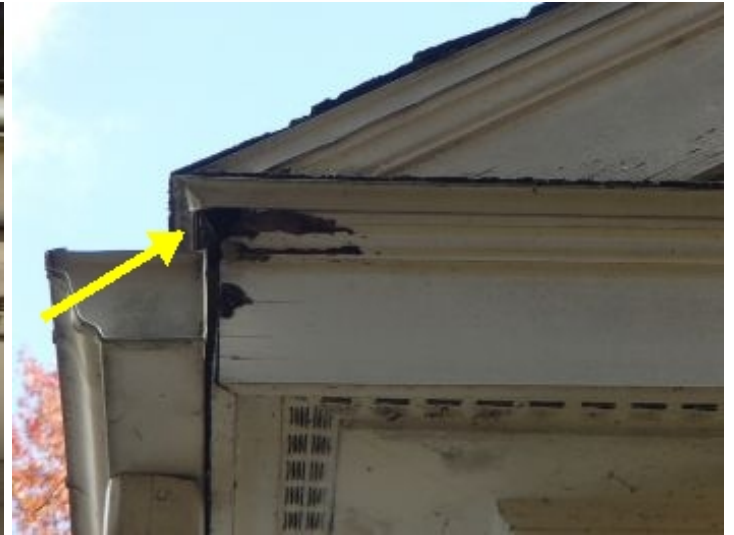
vermin access

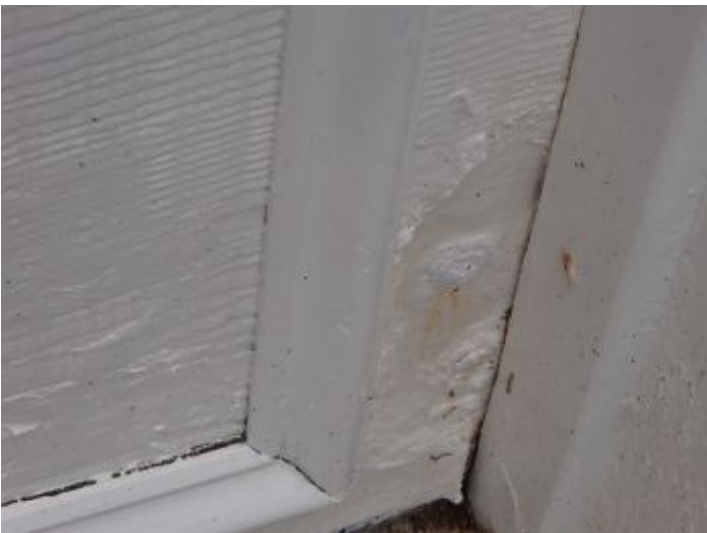
- Damage noted to metal door as pictured, corrosion, it has been painted over.

corrosion, rot on door

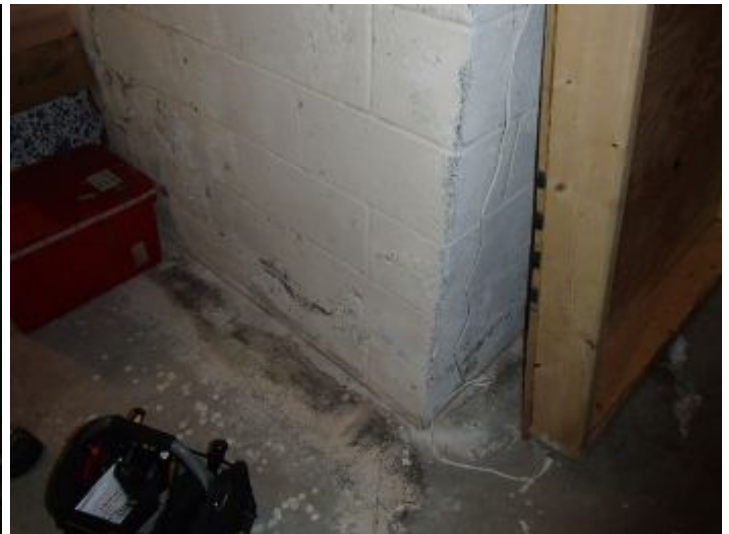
horizontal crack

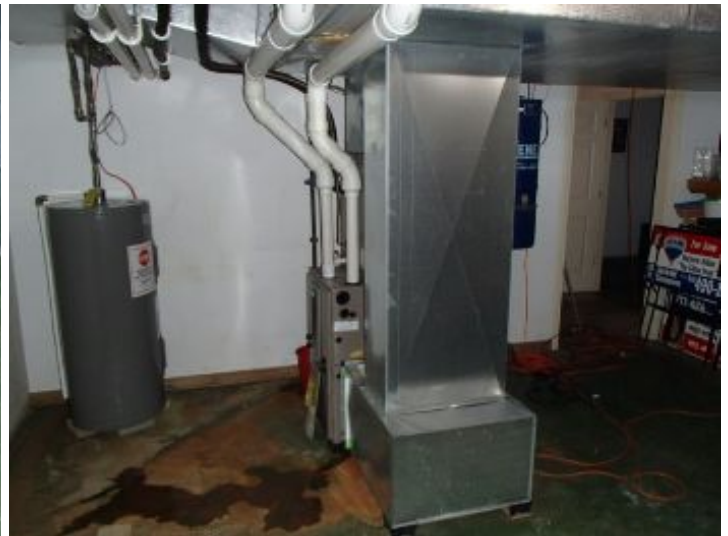
condensate leaking

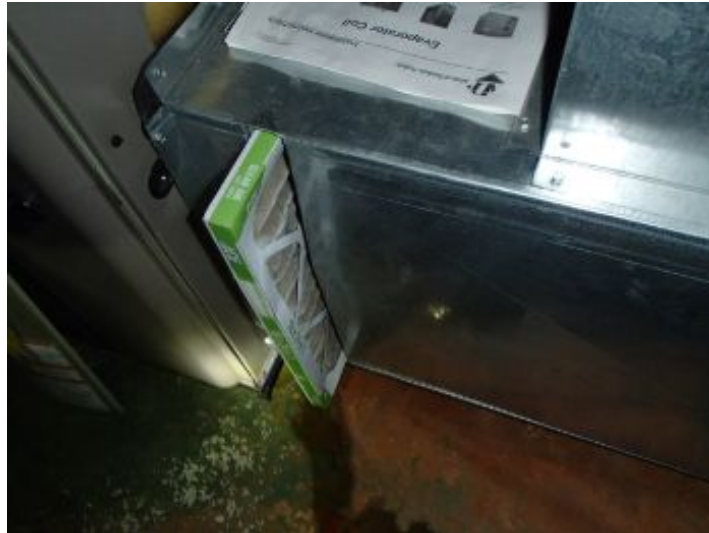
- Filter is dirty, suggest replacement

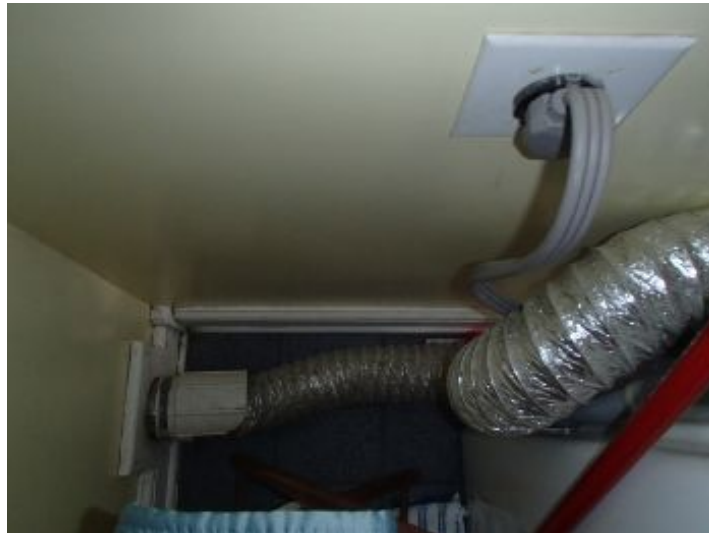
- Dryer has a corrugated vinyl or foil dryer vent pipe. This is a fire hazard as lint can get trapped in pipe. Recommend that the vent pipe be changed by a qualified person.

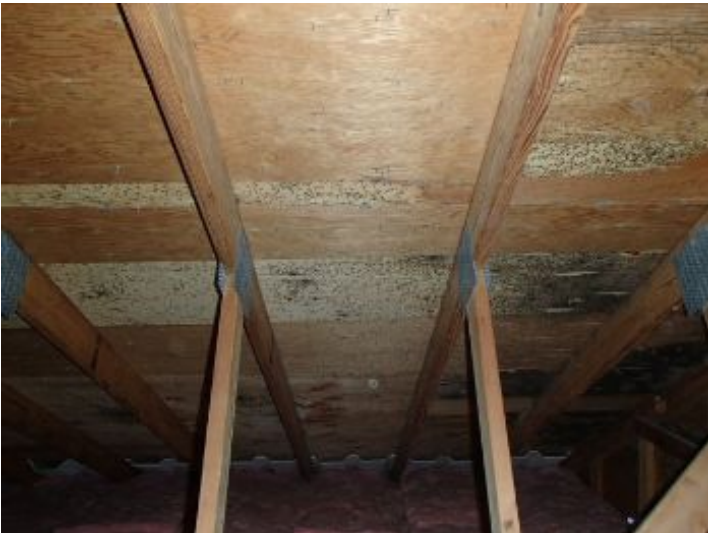
• Mold like growth as pictured on roof sheathing. Area of mold exceeds 10 sq. ft. Mold can be a health hazard. Recommend that a Mold Assessor evaluate and advise client on remediation.

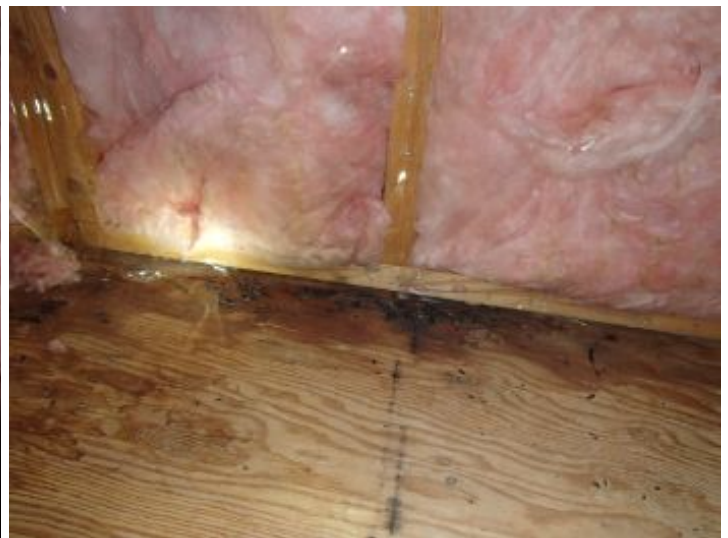
knee wall area, mouse droppings
